Ministerial Report: ***Cross Passage Dundas*** ***rectification works***

Final Report

Date: October 2019

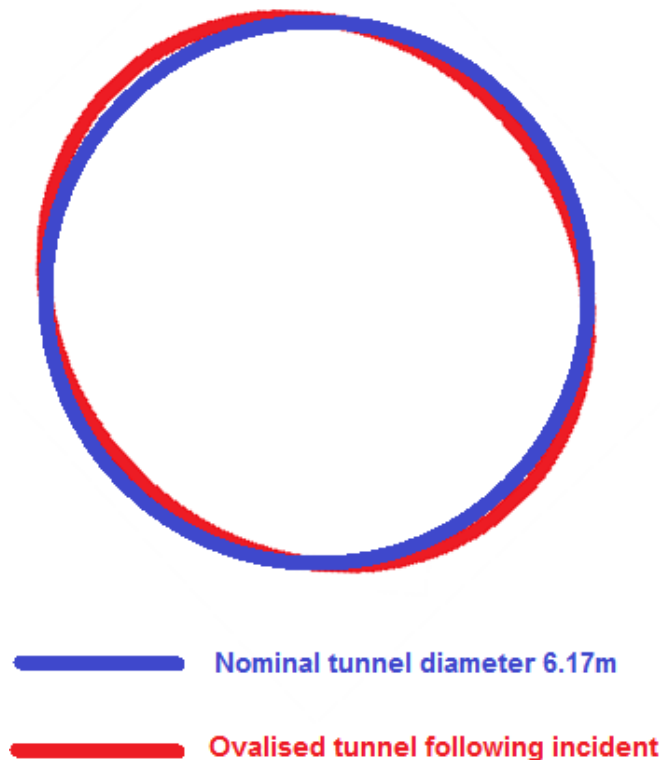
Figure 1 – Diagram of tunnel cross section showing ovalisation

Between Rings 114 and 122, the originally circular cross section of the tunnel experienced an ovalisation, with an increase in the diameter between the top left and bottom right (looking in the direction of excavation) of the tunnel and a shortening of the opposite inclined diameter. The diagram below is exaggerated however it gives an indication of the change in tunnel shape through the damaged section.

The measurement for both diameters was carried out with a laser distometer. The inspection for Ring 115, for example, gave a reading of 6.31m from top left to bottom right and 6.11m from top right to bottom left as opposed to the required length of 6.17m

The change in dimensions to Tunnel One is at its greatest between Ring 113 to 123. On the approach to the cross passage (between Ring 111 and 113) and after the cross passage (Rings 123 and 124) there are transition zones between the impacted stretch and the return to design specification. This ovalisation has had various impacts on the tunnel surface, including tension cracks and steps or lips between tunnel segments.

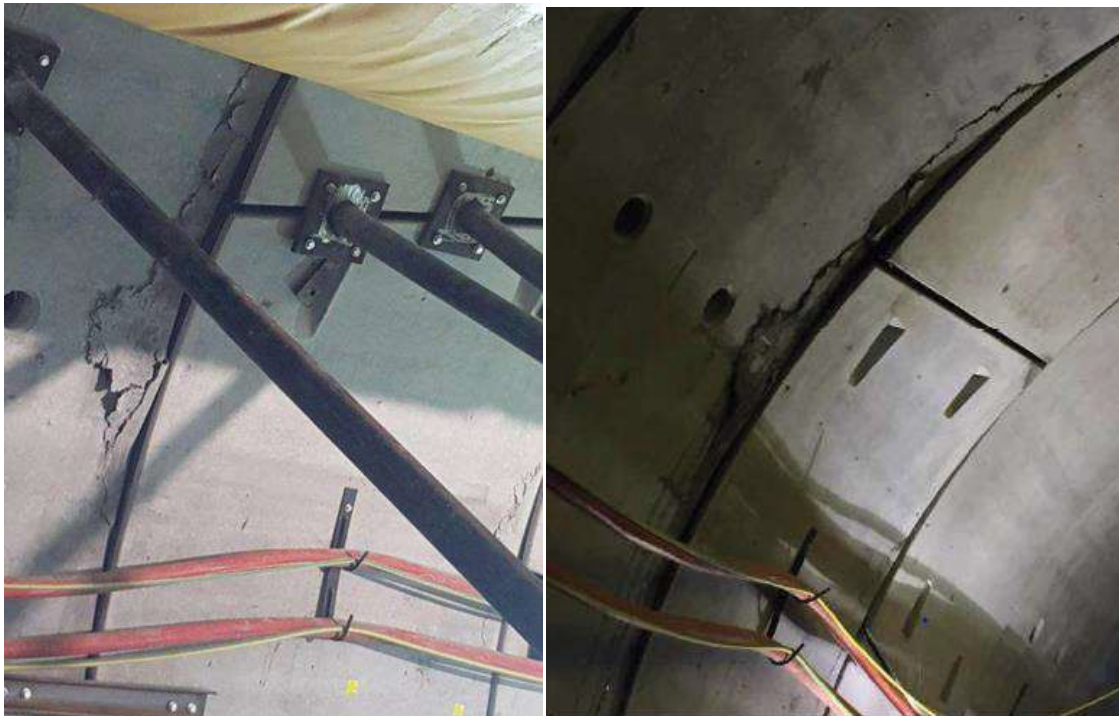
Figure 2 - View of Ring 117 (left) and Ring 120 (right) both with tension cracks and lips

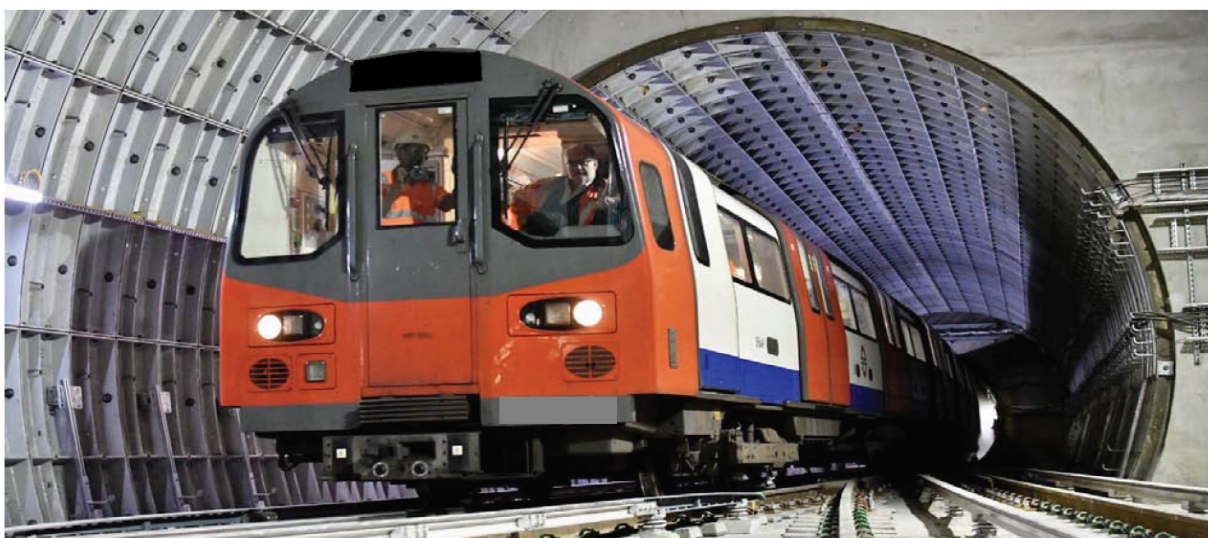
Figure 4: London Underground Kennington Loop SGI step plate junction
